Portage Creek Sediment Remediation Project Kalamazoo, Michigan

Post-Sediment Removal Structure Feature Assessment
Removal Areas SA1-A, SA1-B and SA1-C

F&V Project Number: 809930
October, 2013

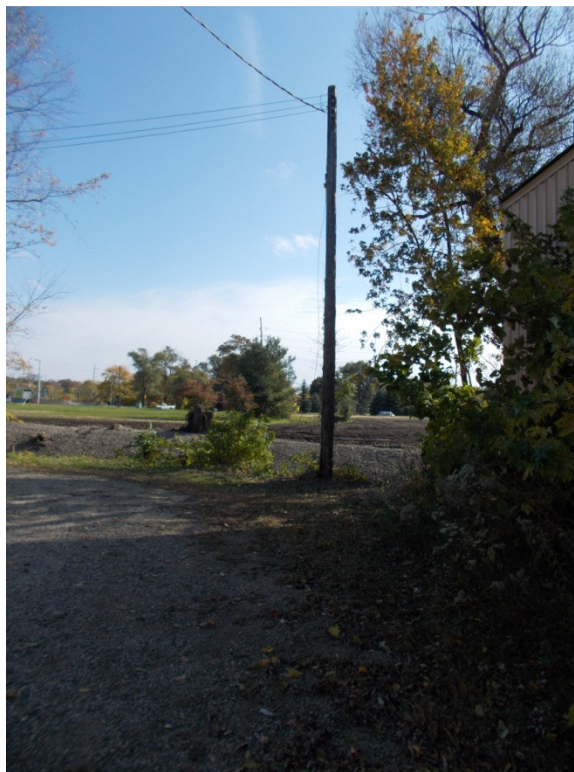
Designation: SA1-A-S01

- The guy wire that had been tangled in woody debris in the channel is now hanging loose on the west bank.
- The structure does not appear to have been impacted during sediment removal.

Pole viewed from the west

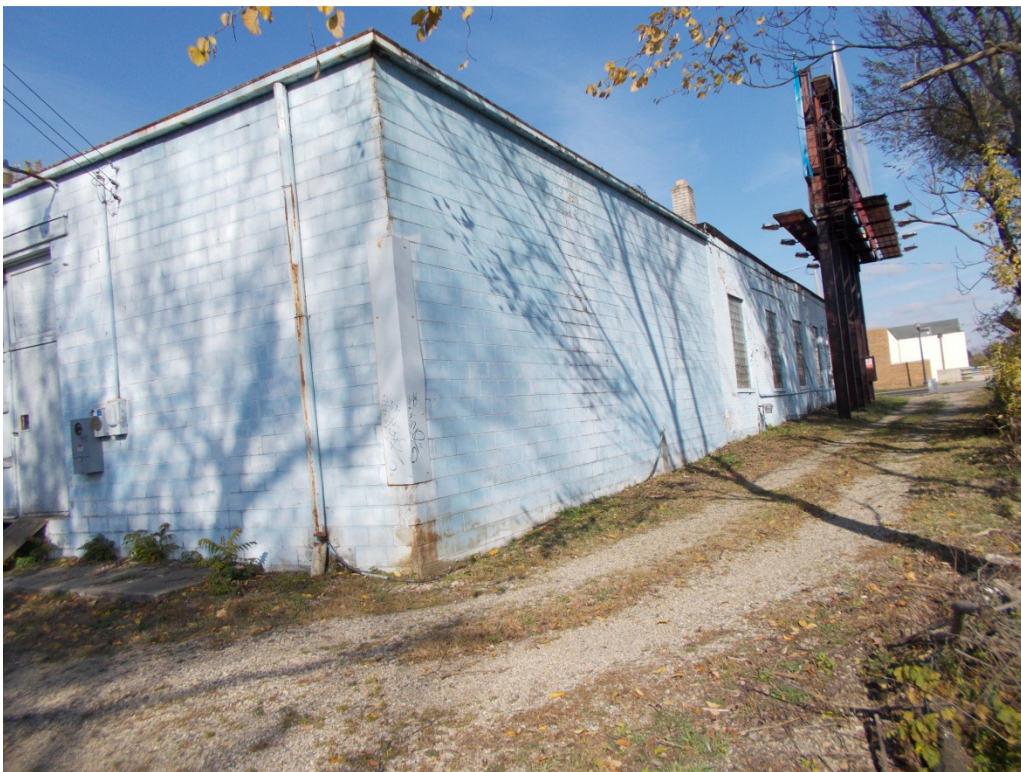
Designation: SA1-A-S02

- Cracking observed does not appear to have changed.
- The structure does not appear to have been impacted during sediment removal.

View of the structure looking northwest

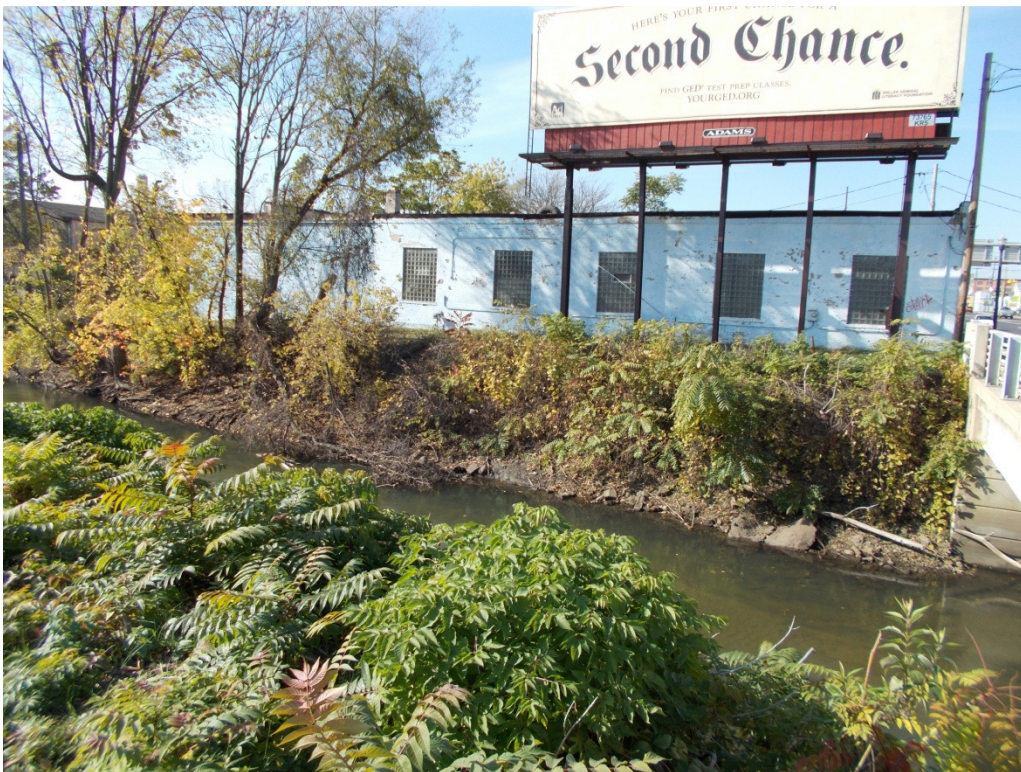
View of the structure from the east bank

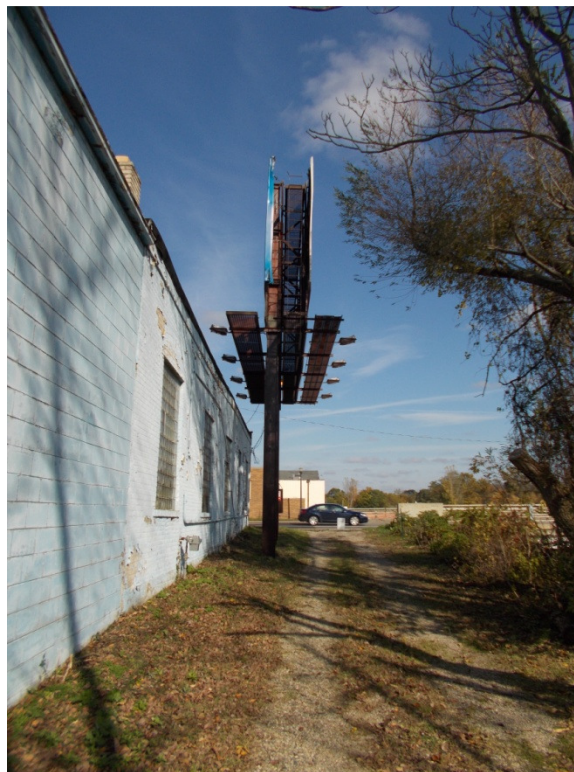
Designation: SA1-A-S03

- The structure does not appear to have been impacted during sediment removal.

View of the structure looking north

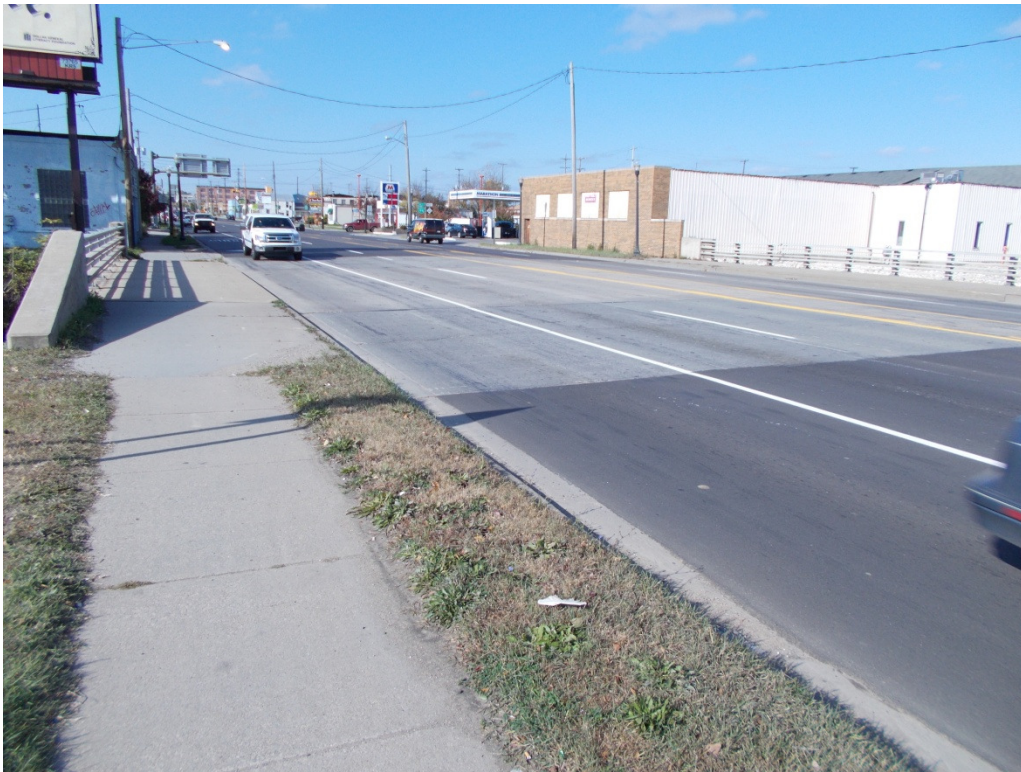
Designation: SA1-A-S07

- Restoration is ongoing in the southeast quadrant.
- The northwest quadrant has been cleared and restored with riprap.
- The structure does not appear to have been impacted during sediment removal.

View of structure from the southeast approach area

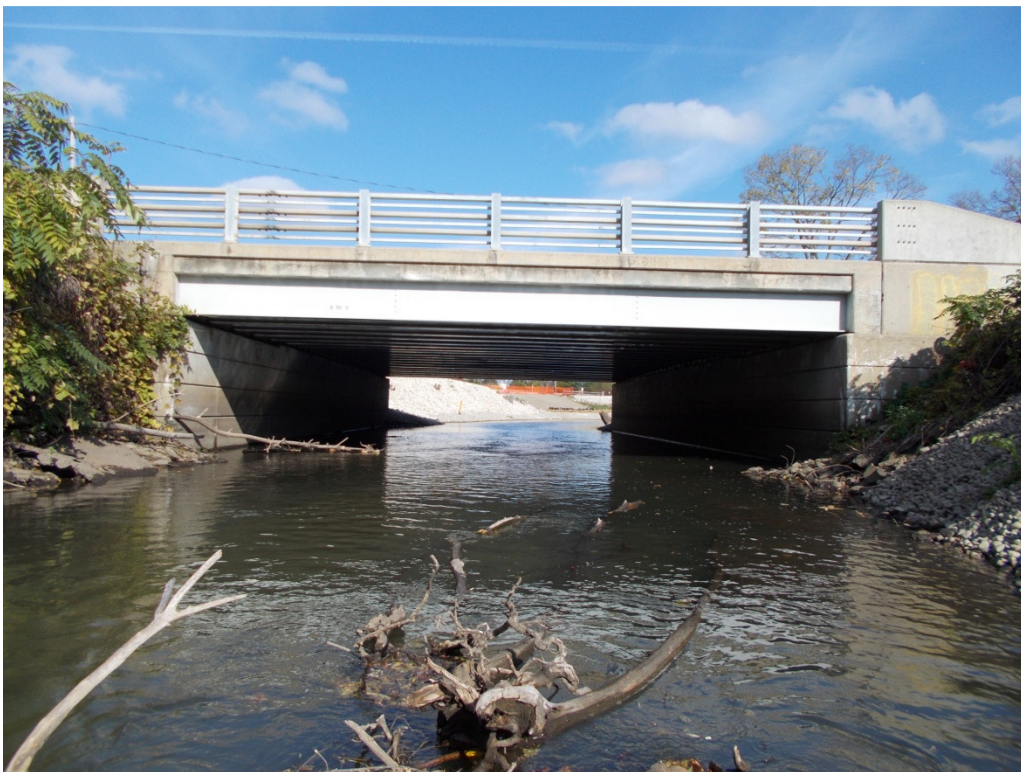
Elevation view of the structure

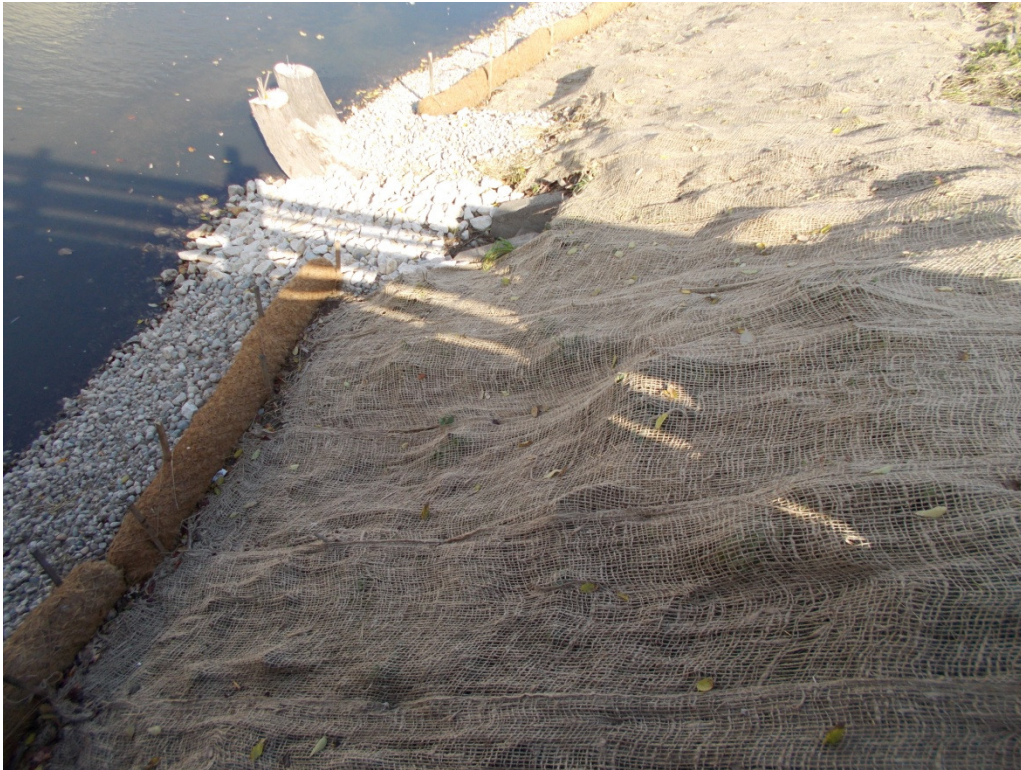
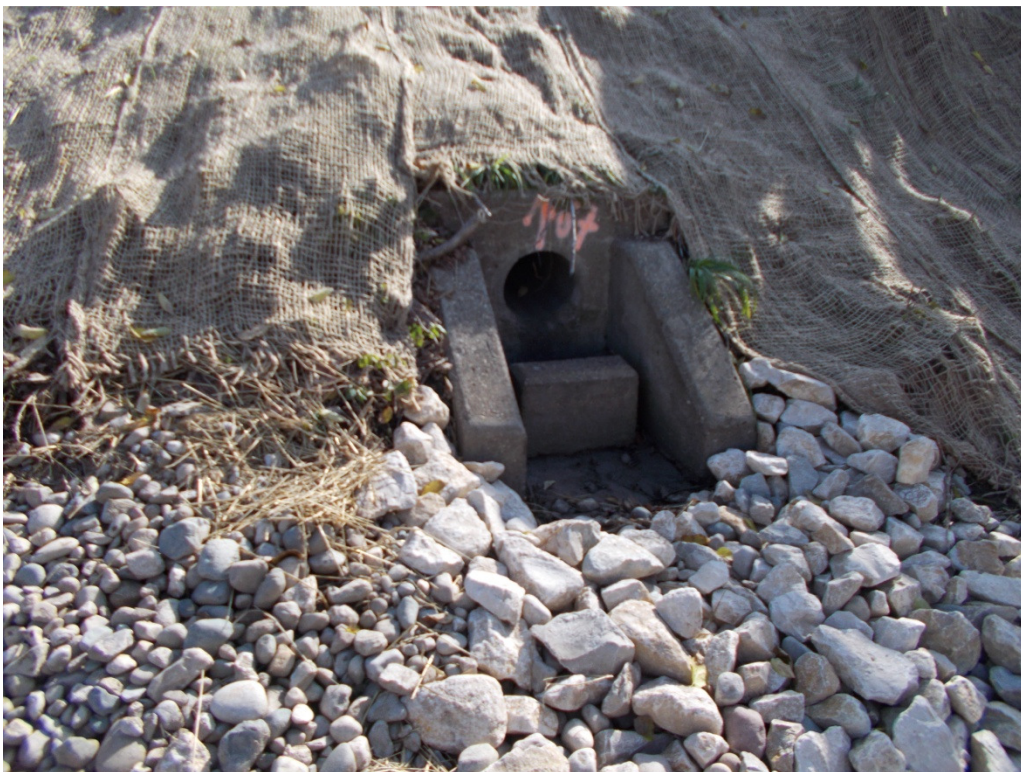
Designation: SA1-A-S08

- The structure does not appear to have been impacted during sediment removal.

View of structure looking north

Close-up view of the structure

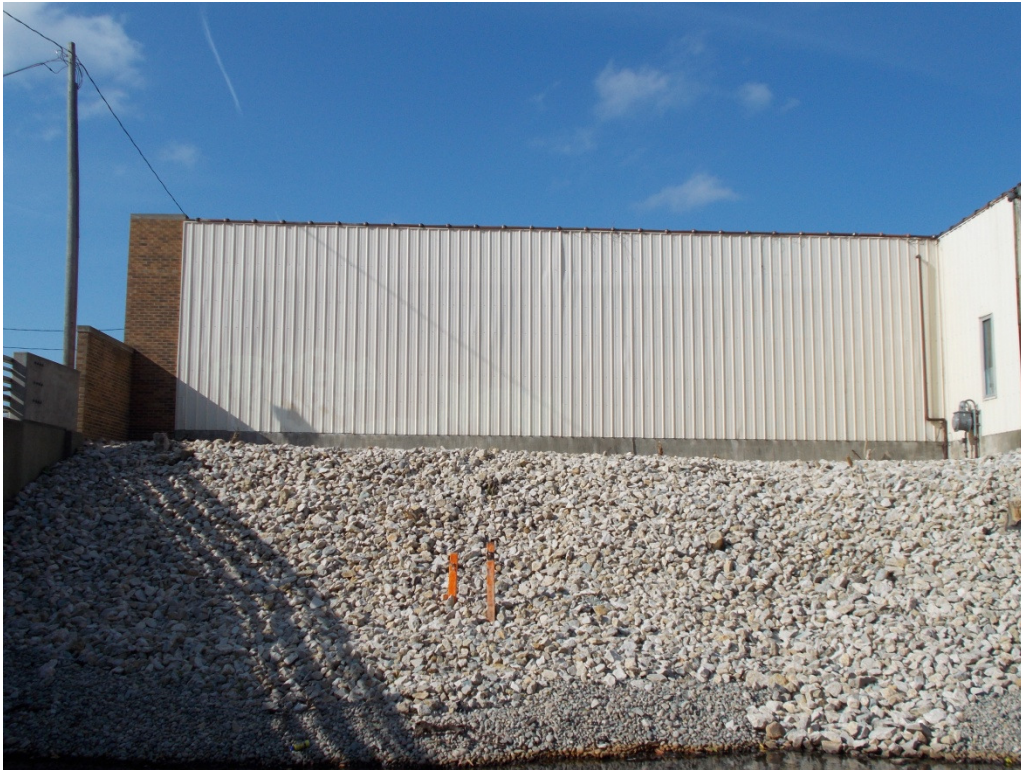
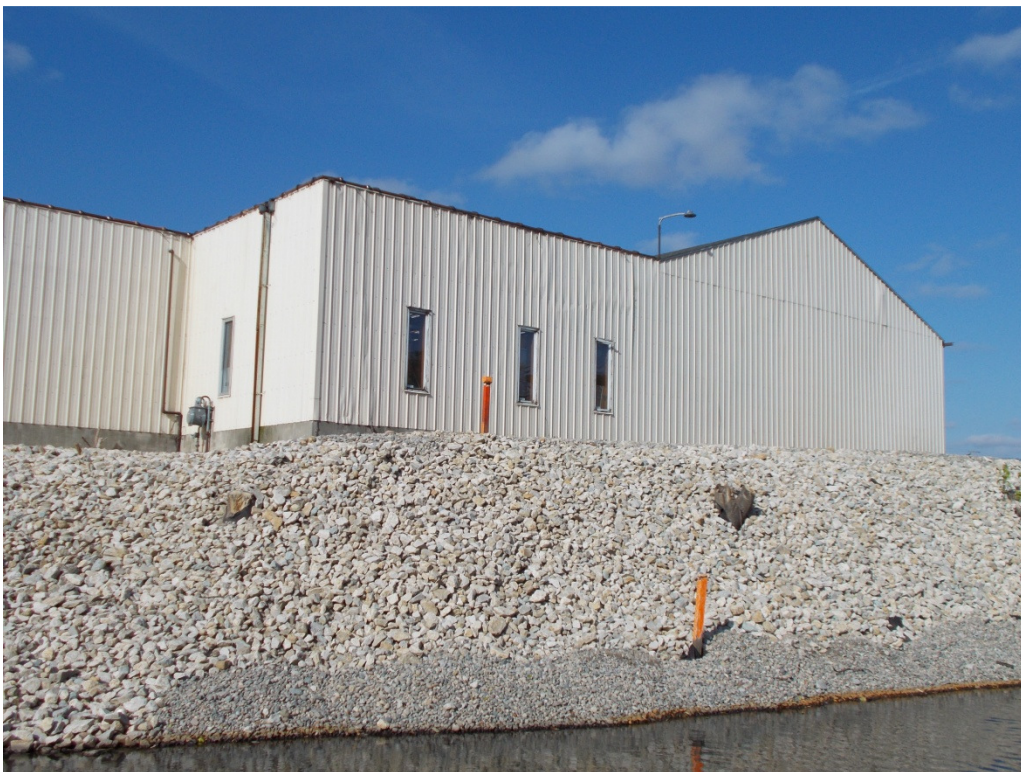
Designation: SA1-A-S10

- Cracking in the brick extension wall appears to be unchanged.
- The bank along the structure has been cleared and restored with riprap.
- The structure does not appear to have been impacted during sediment removal.

View of structure from the channel

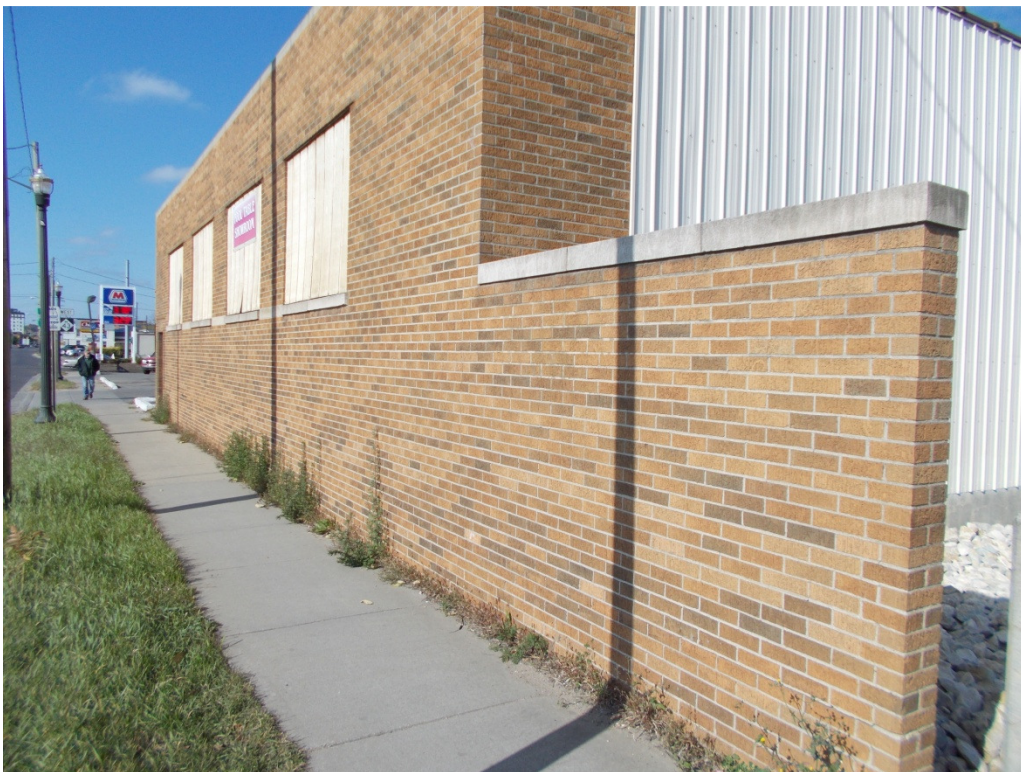
View of brick façade on south side of structure

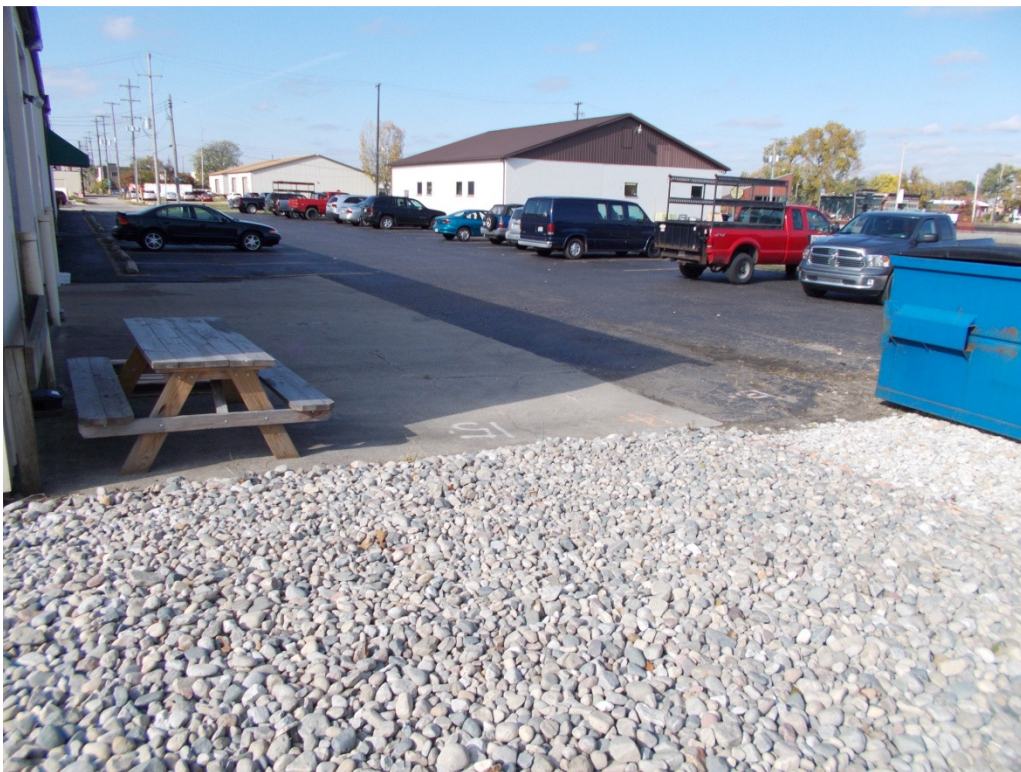
View of concrete and asphalt area on the north side of the structure

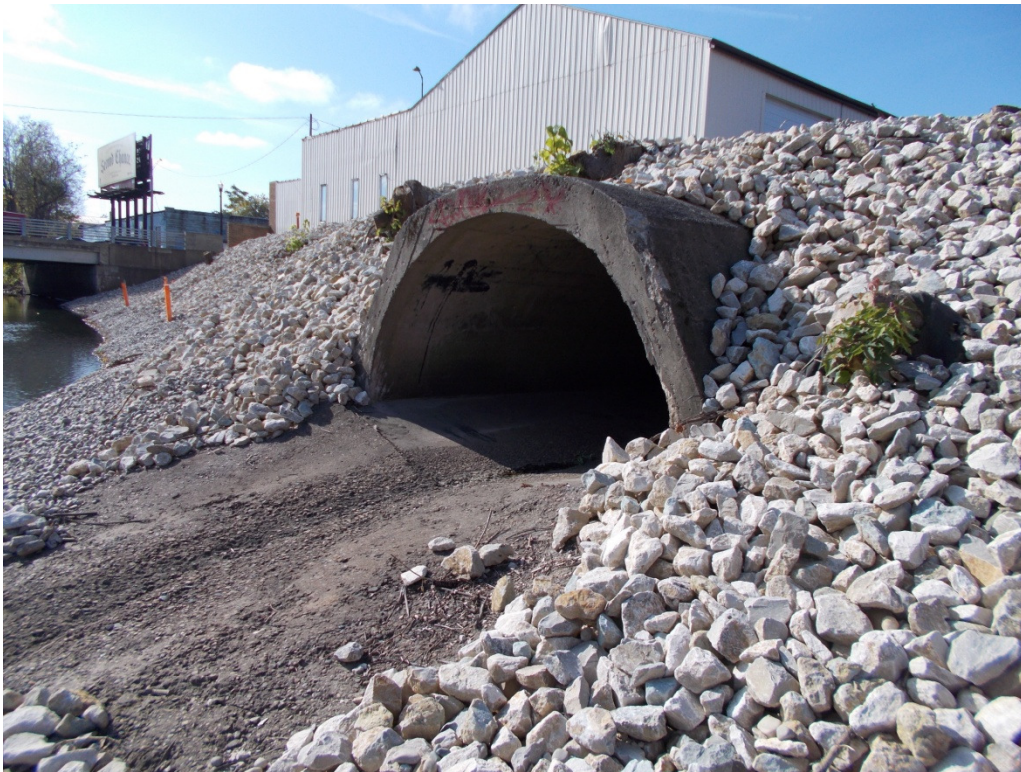
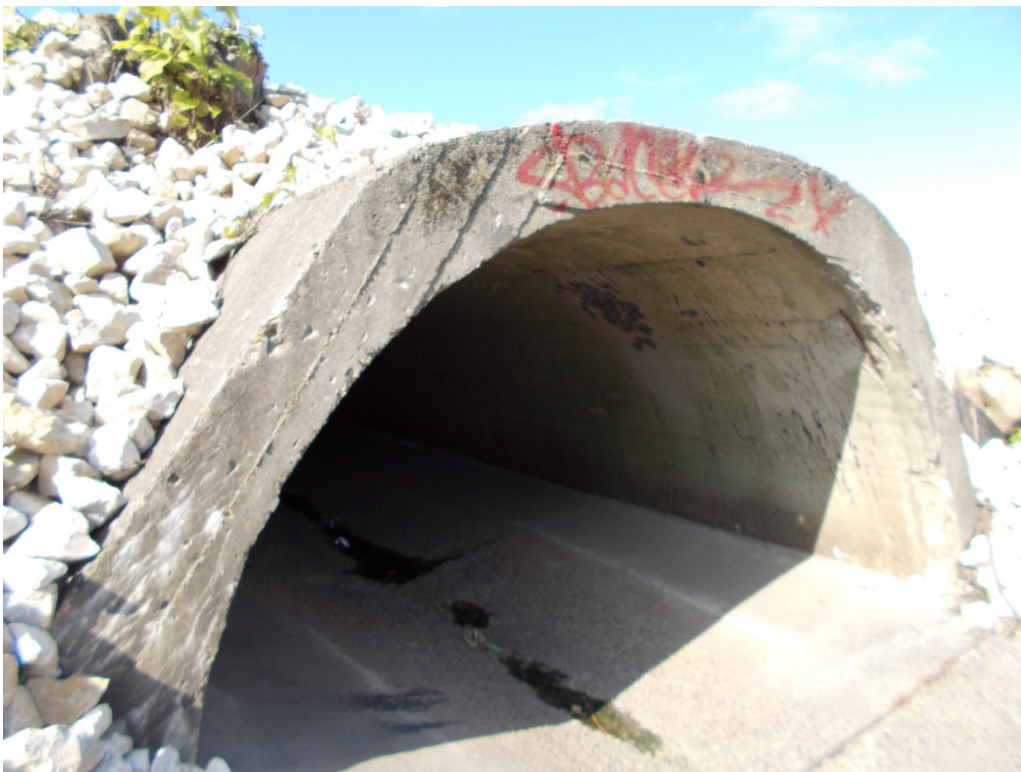
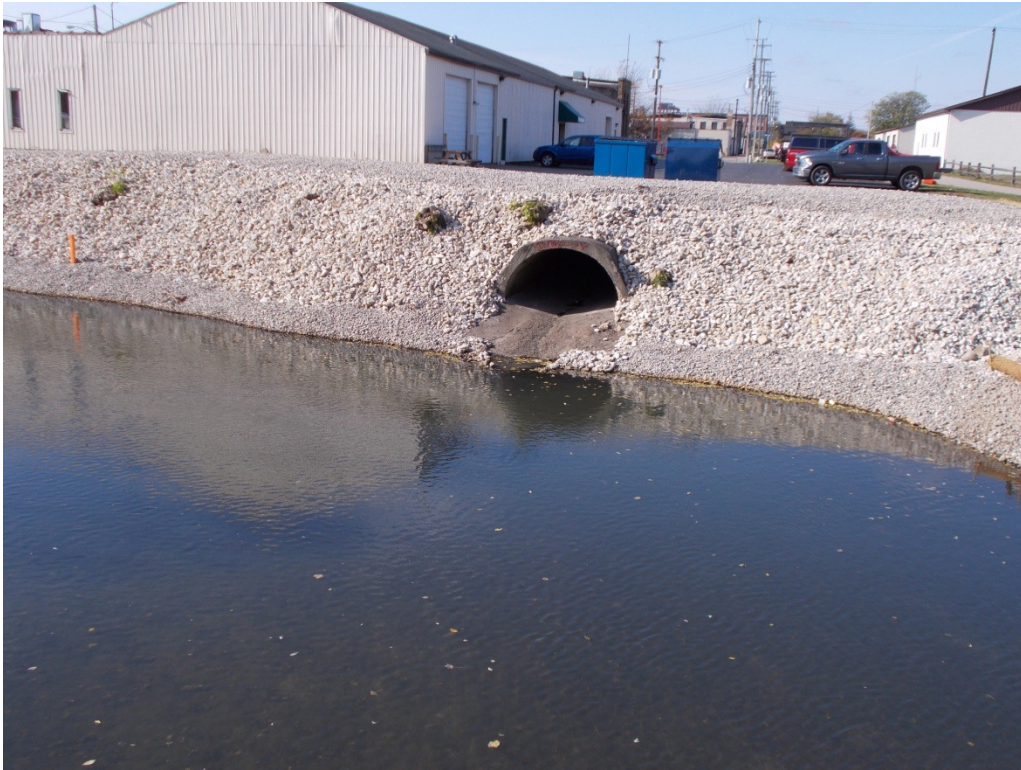
Designation: SA1-A-S11

- The bank around the structure has been cleared and restored with riprap.
- The structure does not appear to have been impacted during sediment removal.

View of structure looking southwest

View of structure looking northwest

View of structure from the east bank

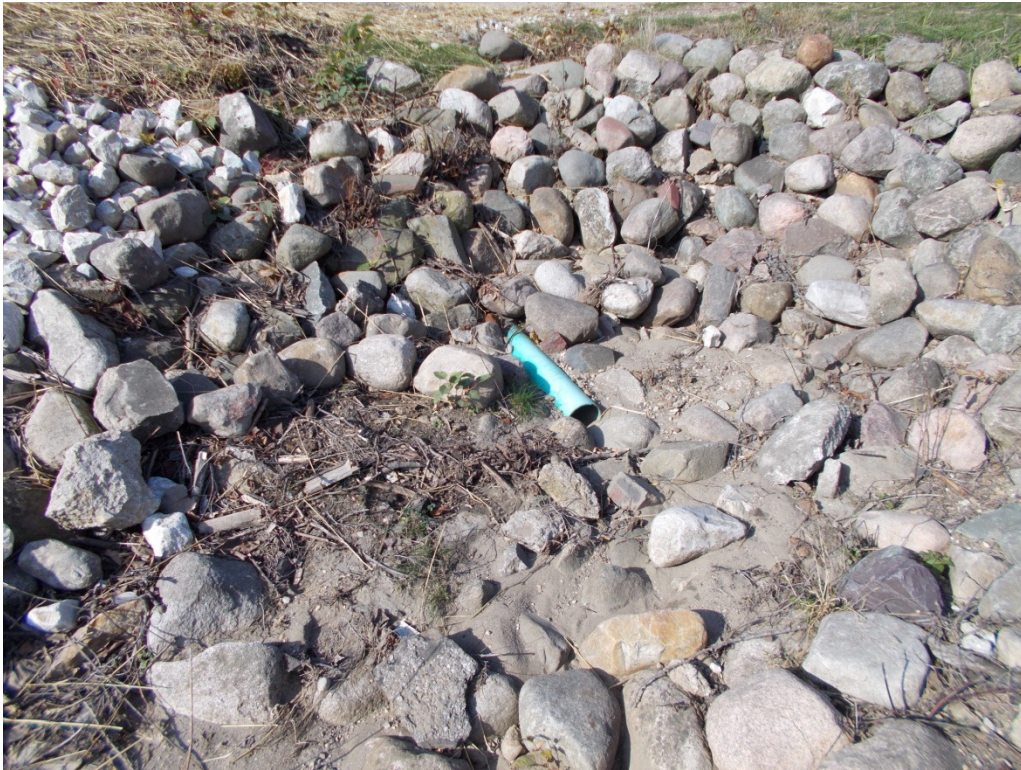
Designation: SA1-A-S12

- The structure does not appear to have been impacted during sediment removal.

View of structure from the water's edge

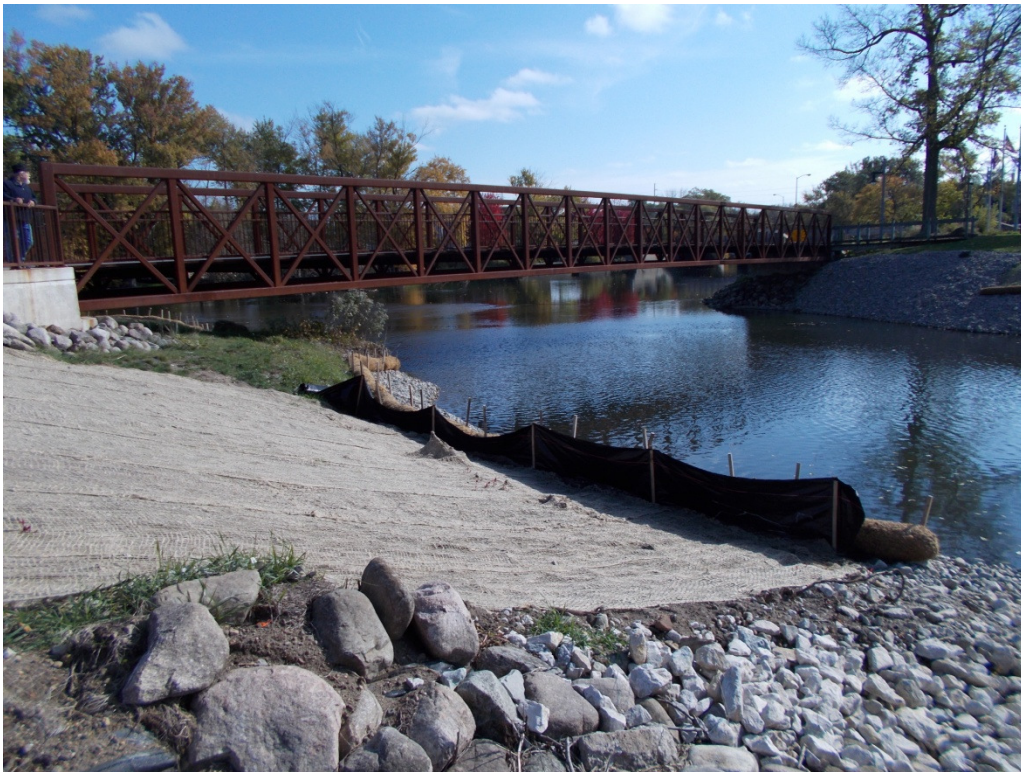
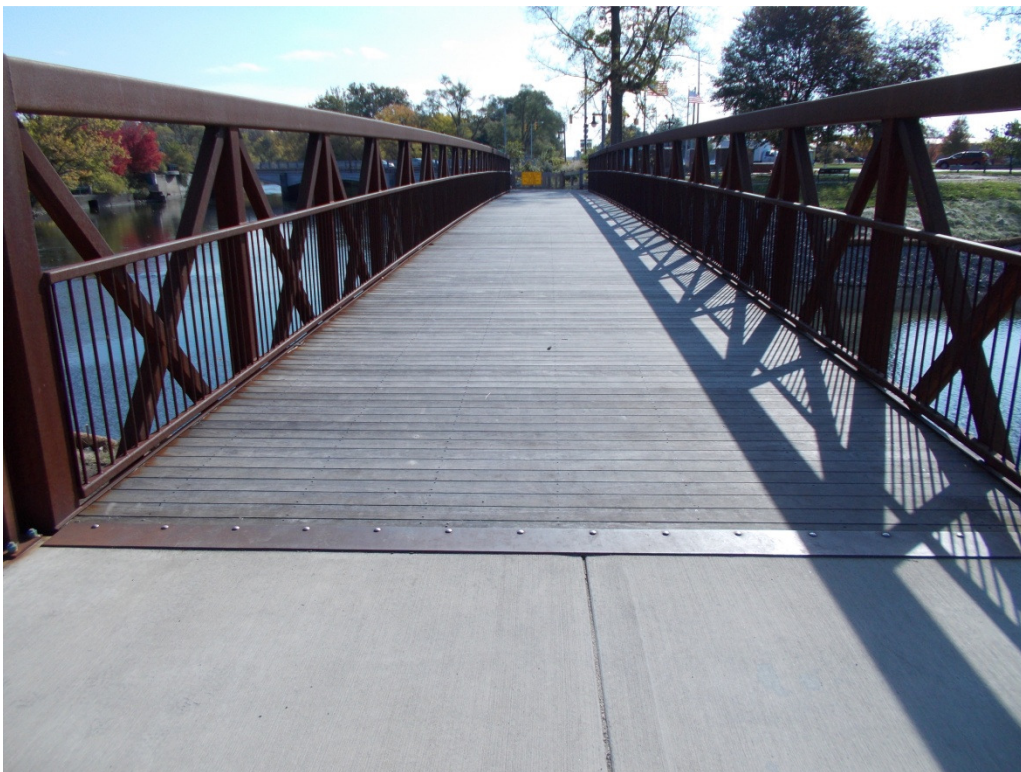
Location: SA1-A-S13 is the Rose Park pedestrian bridge.

- Trees and other landscaping in the northwest quadrant have been removed.
- Restoration is ongoing in the northwest quadrant.
- The monitoring well in the northwest quadrant appears to have been preserved.
- Repair of the split rail fence in the northwest was nearly complete at the time of evaluation.
- There are a number of cracked flags of concrete sidewalk in the southeast quadrant. They appear to be marked for replacement along with extension of the walk to the east.
- The structure itself does not appear to have been impacted during sediment removal.

Elevation view of structure looking northeast

View of structure from the west approach

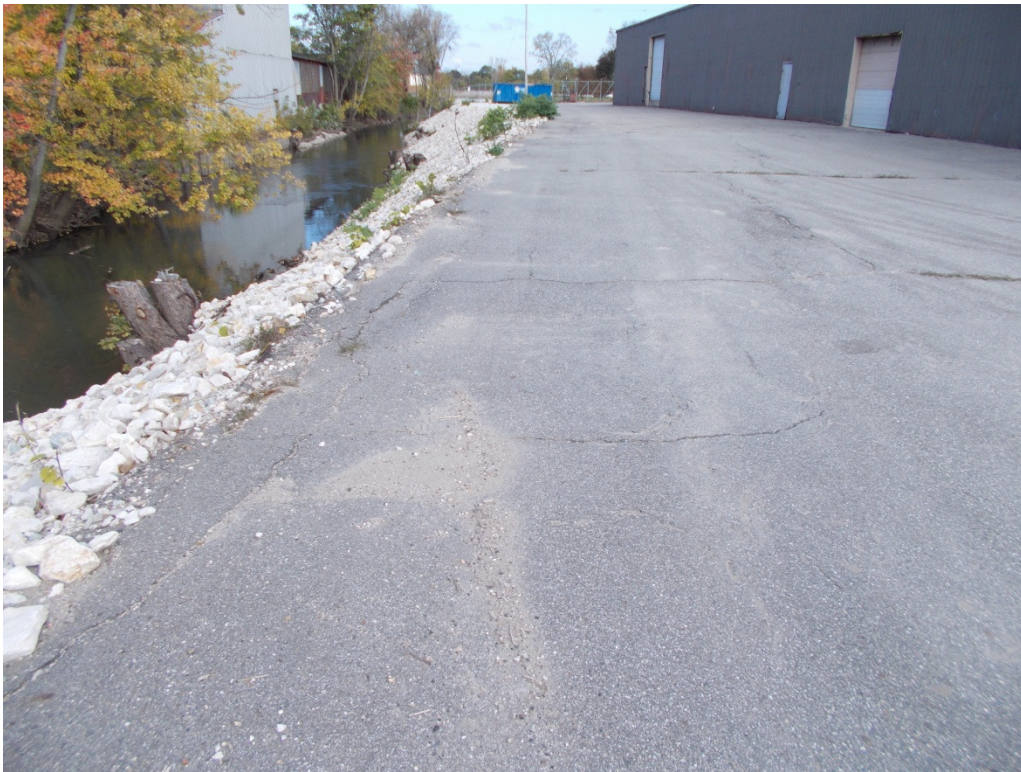
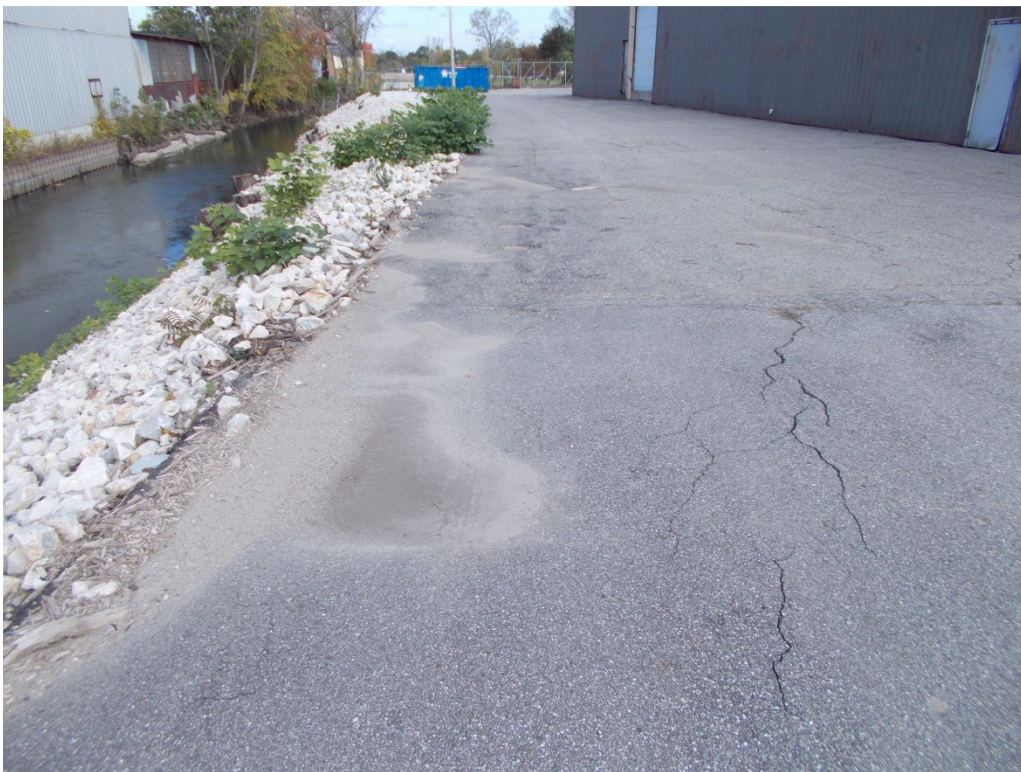
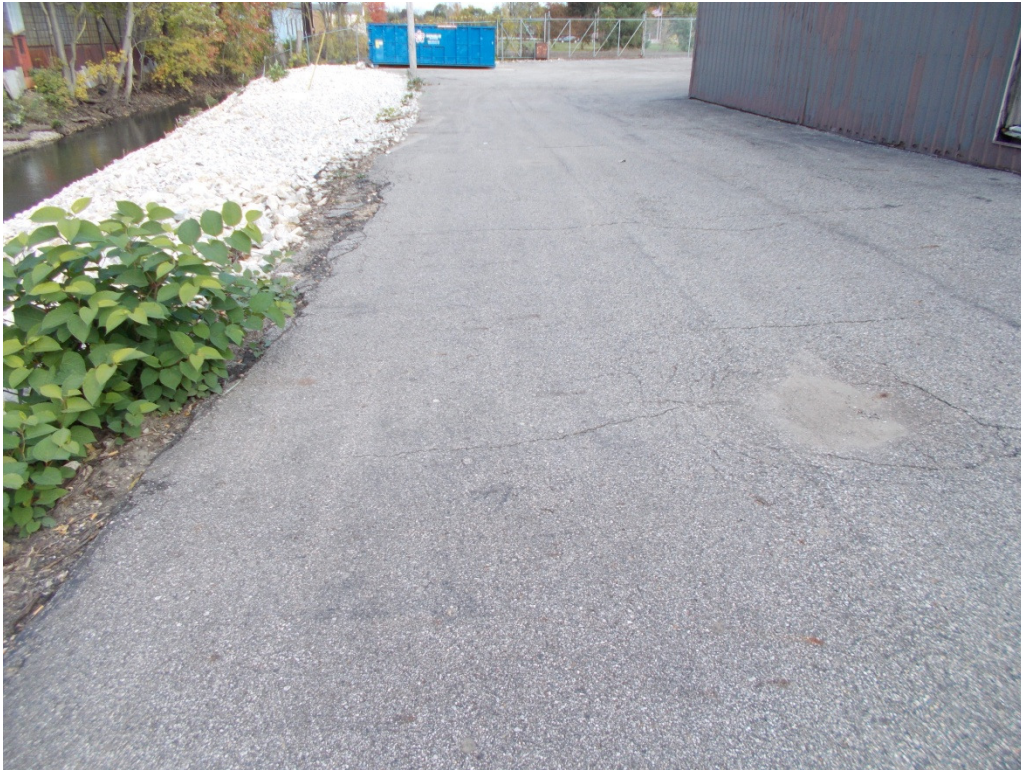
- Generally, the structure does not appear to have been impacted during sediment removal.
- Loose/failing concrete appears to have been removed from the dumpster parking block.
- One isolated area of failed pavement in the northeast appears to be marked for replacement.

View of pavement area looking north toward SA1-B

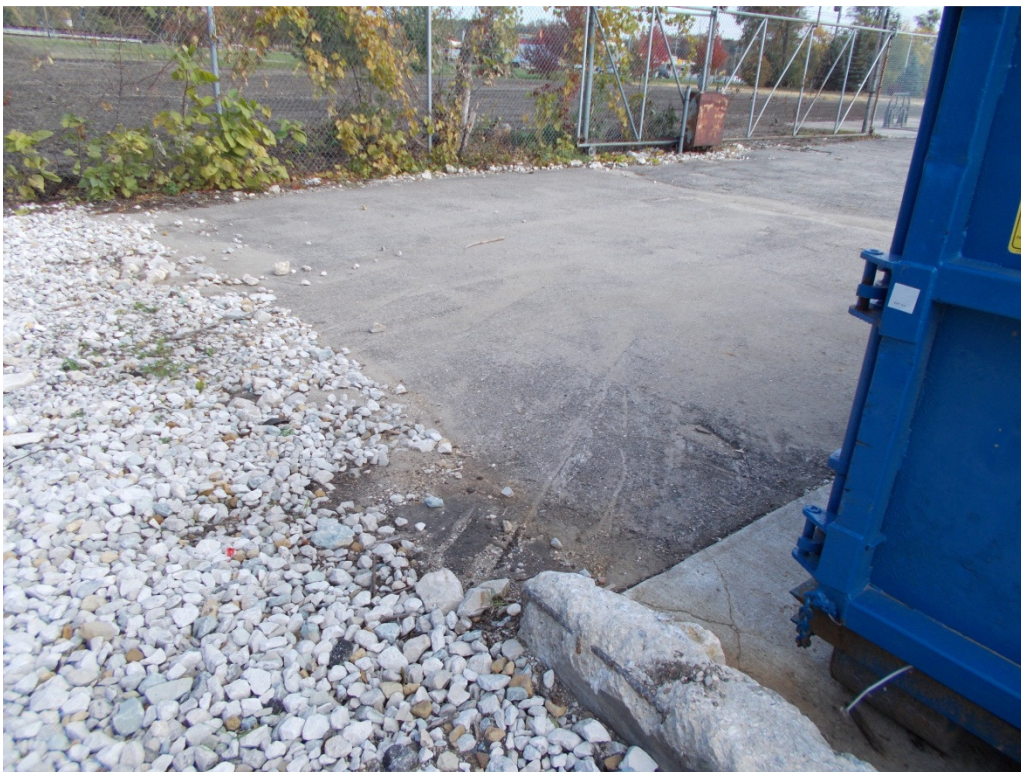
View of asphalt pavement north of the dumpster pad

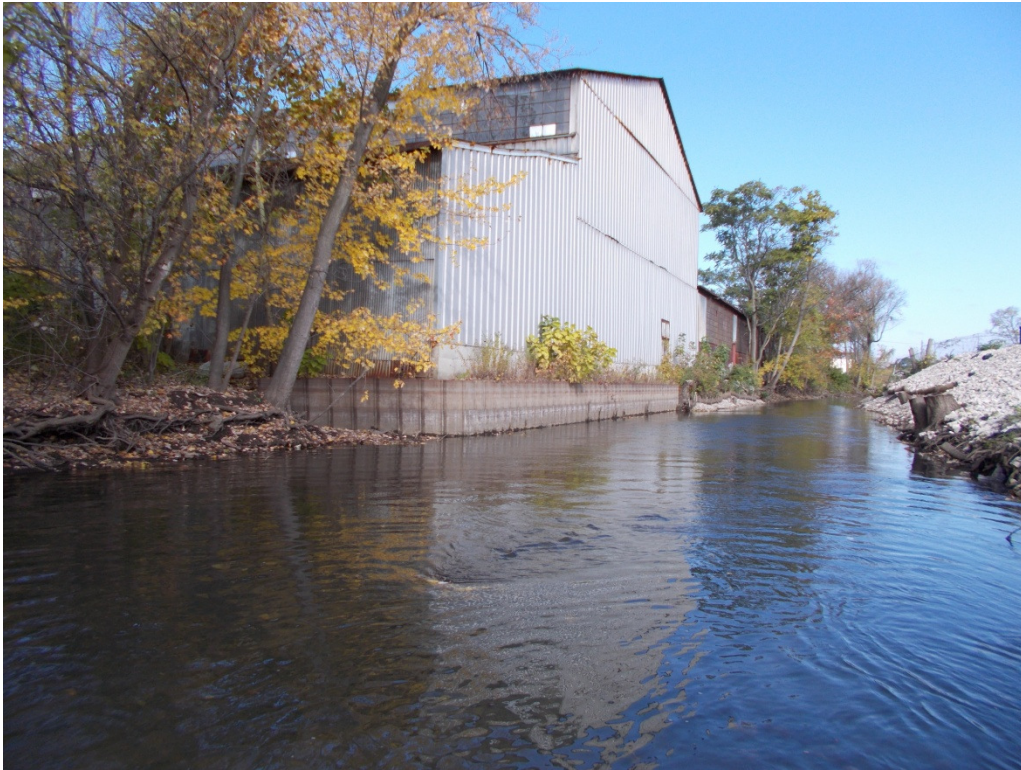
- Cracking and undermining observed does not appear to have changed.
- The structure does not appear to have been impacted during sediment removal.

View of the structure looking north

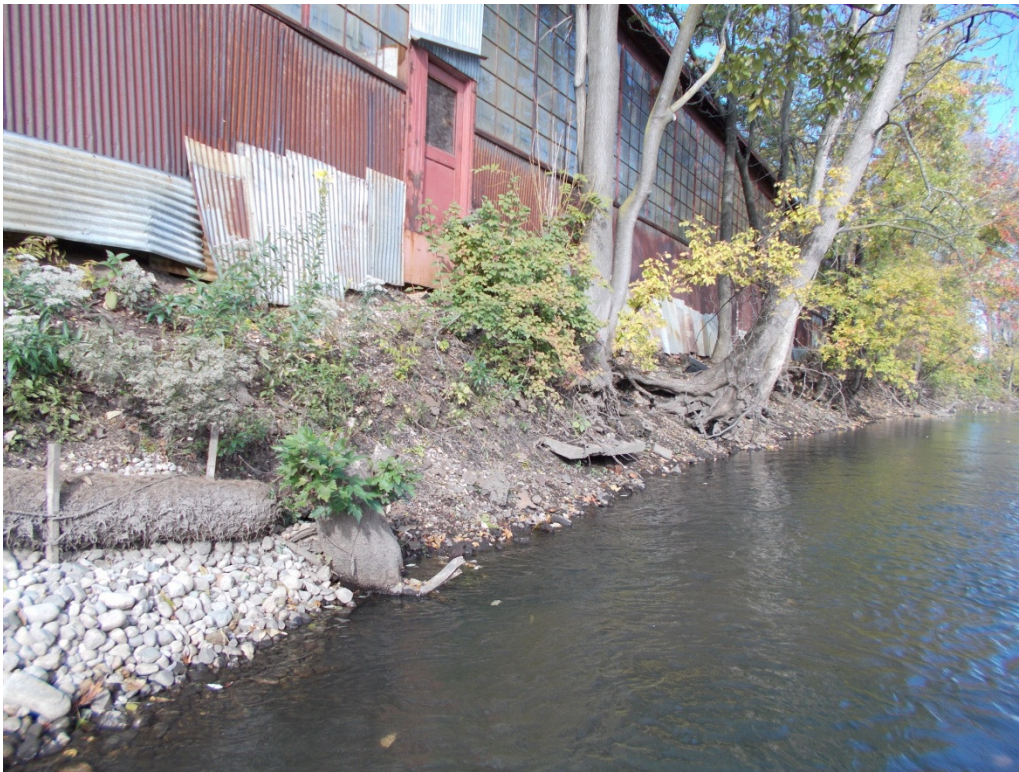
View of bank along north section of building

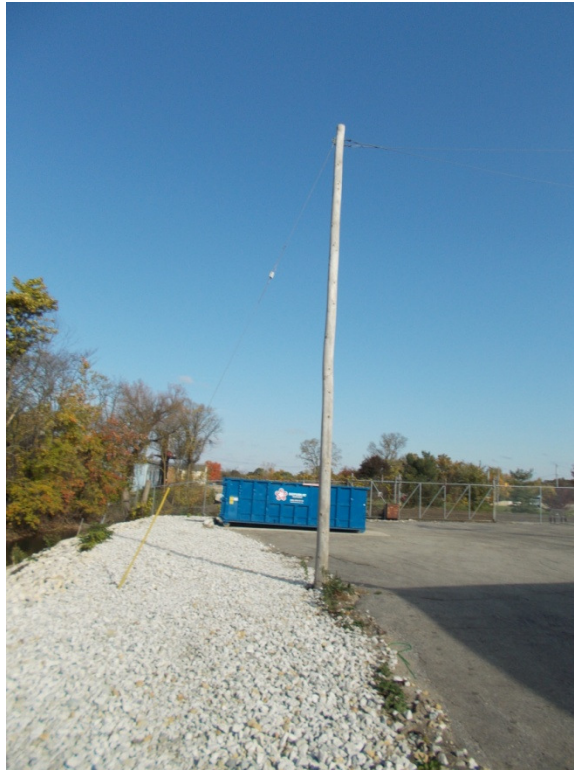
- The structure does not appear to have been impacted during sediment removal.

View of the guy pole and wire looking north

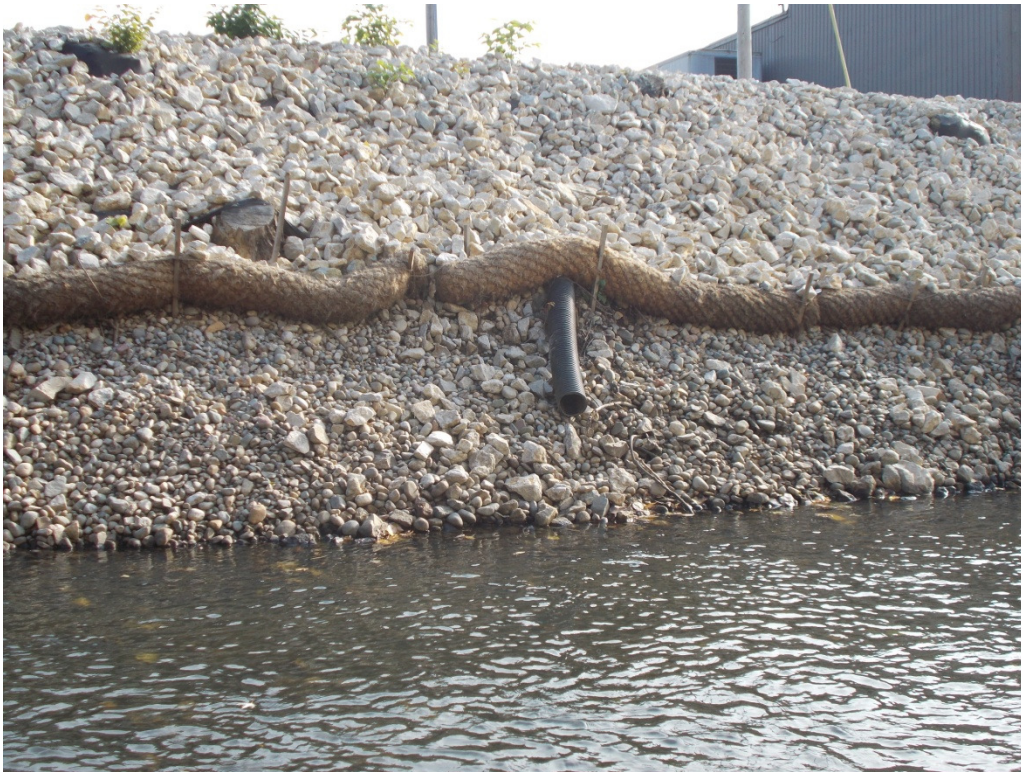
Designation: SA1-B-S05

- The structure does not appear to have been impacted during sediment removal.

View of the structure from the channel

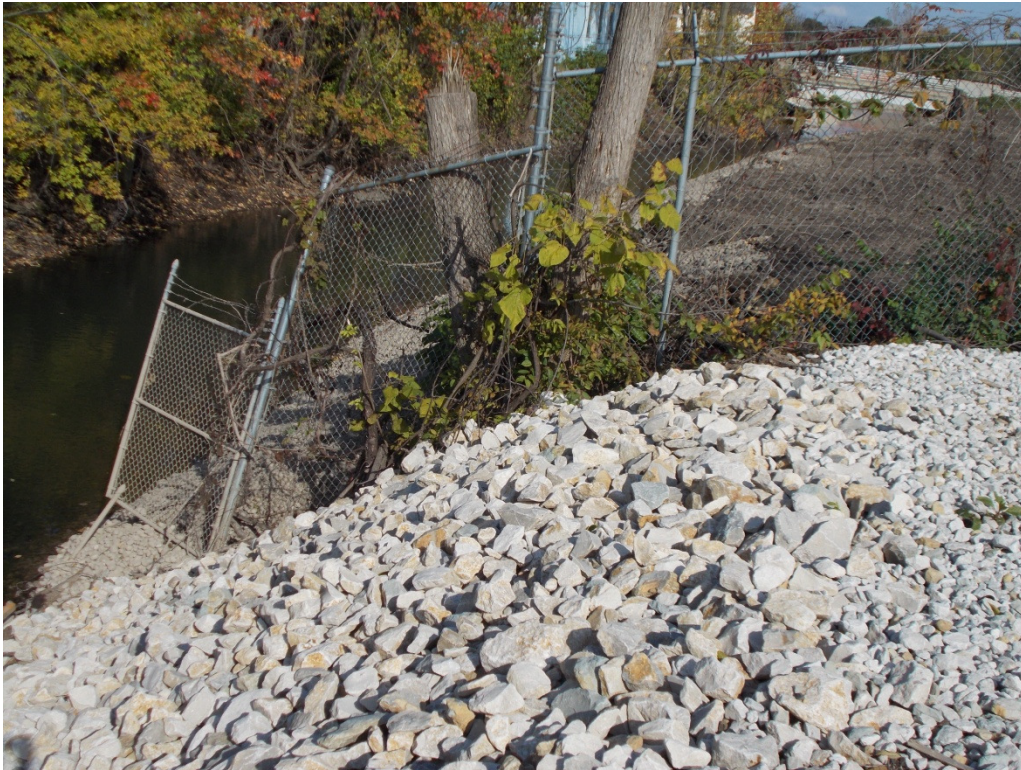
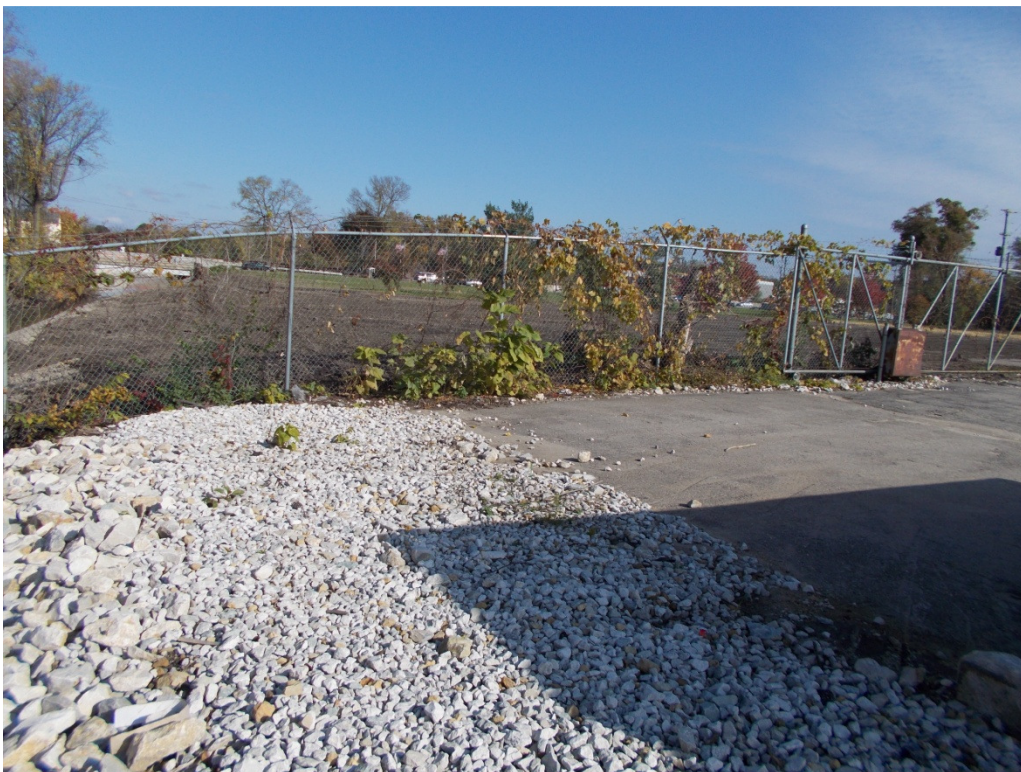
Designation: SA1-B-S06

- The structure does not appear to have been impacted during sediment removal.

View of the fence looking northwest

View of the fence looking north
